POST-HURRICANE IRMA UPDATE NOVEMBER 6, 2017

MANASOTA KEY NORTH 10-YR BEACH MANAGEMENT PLAN

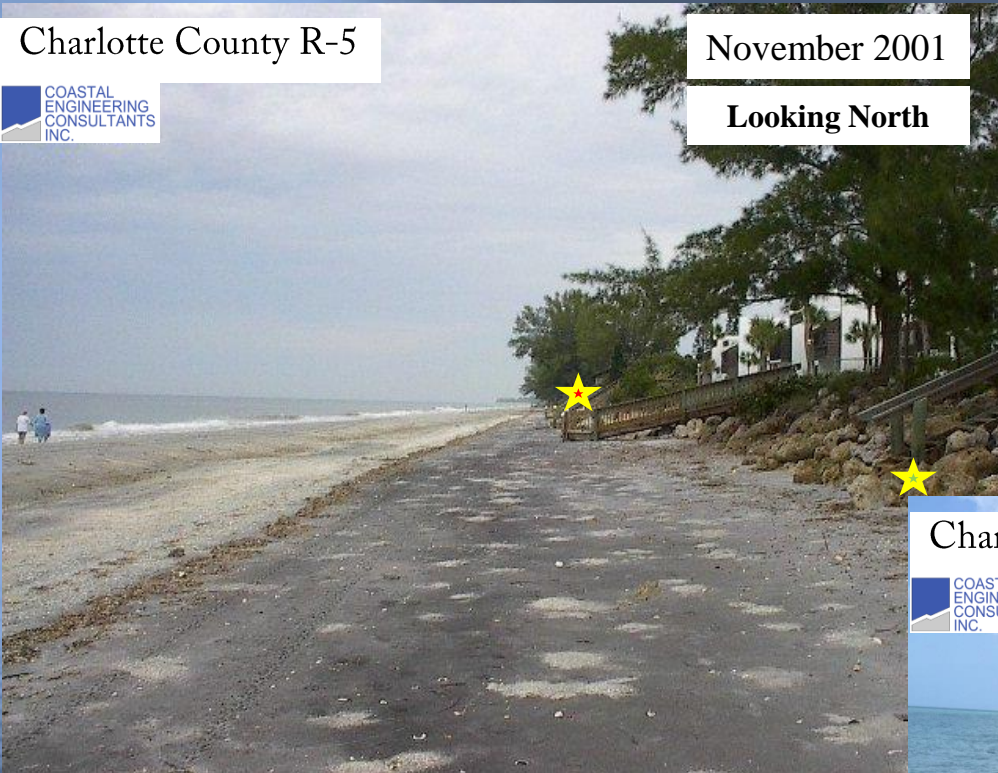
Charlotte County R-5

November 2001

Looking North

**2001 Beach
Erosion Study
Conditions**

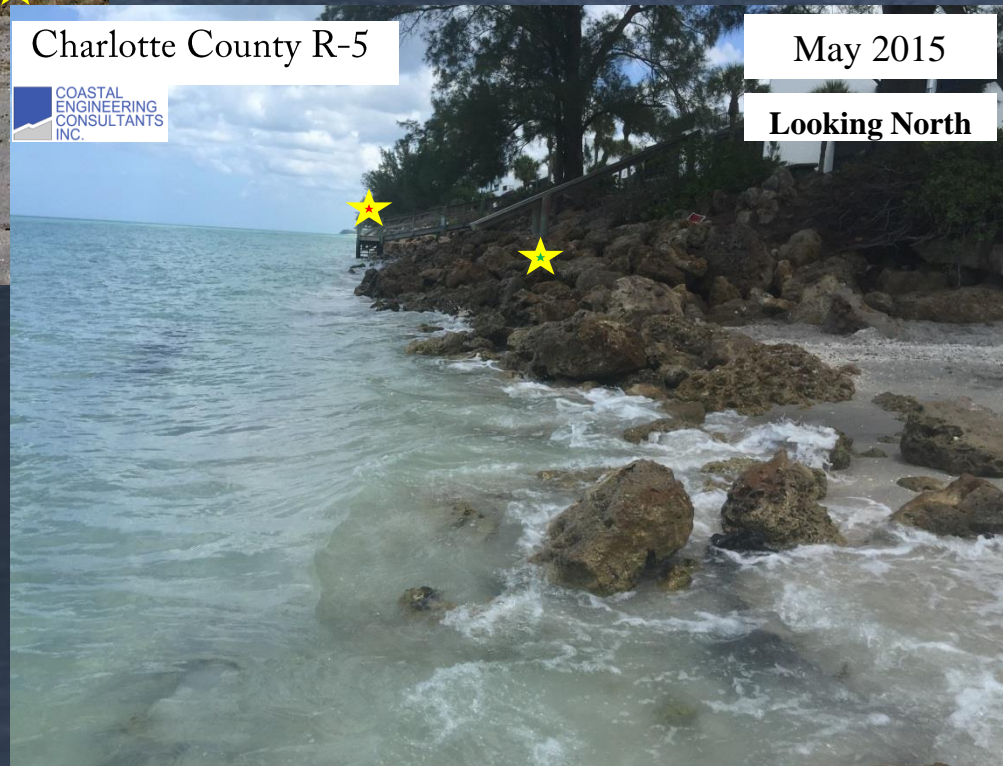
Charlotte County R-5

May 2015

Looking North

**2015 Beach
Erosion Update
Conditions**

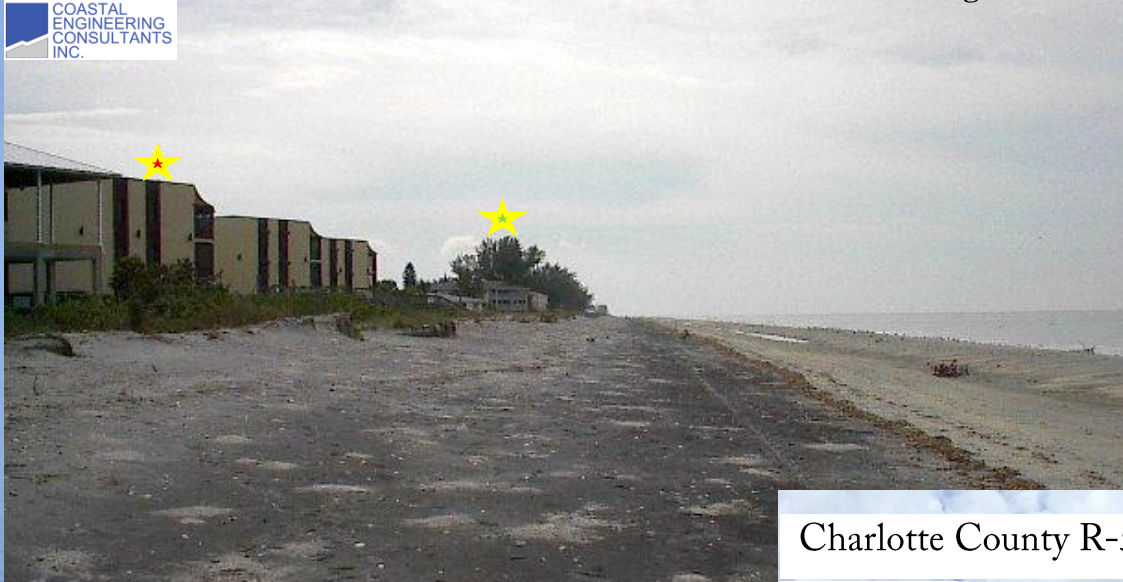
Charlotte County R-5

November 2001
Looking South

2001 Beach
Erosion Study
Conditions

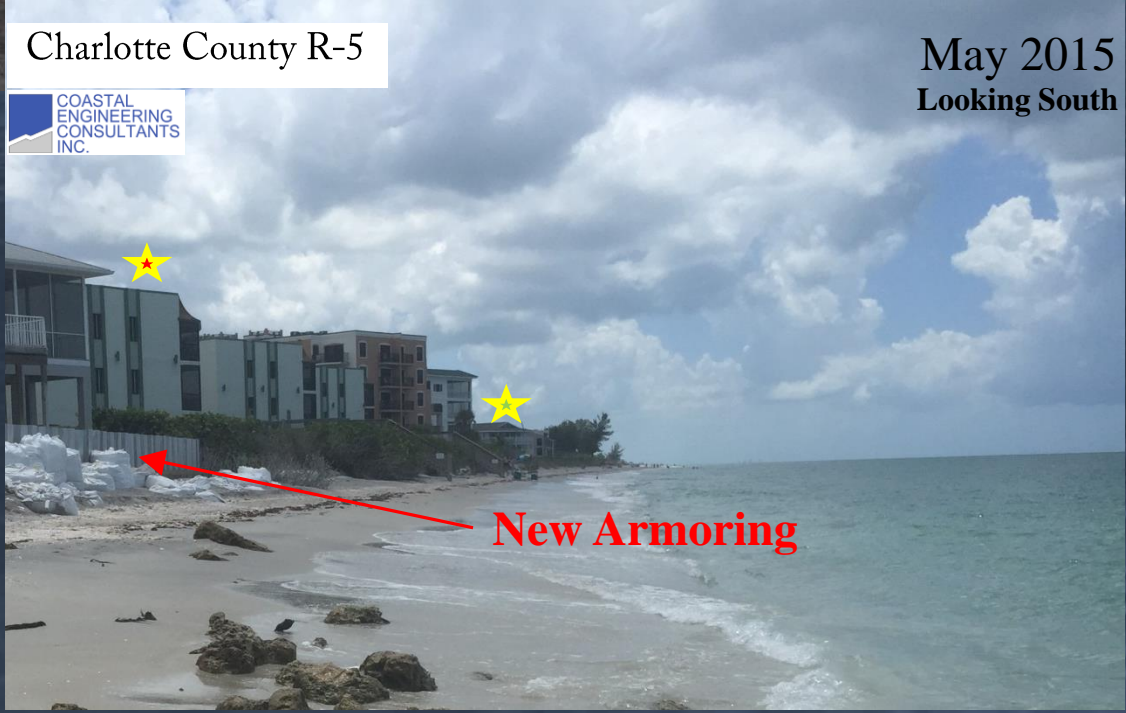
Charlotte County R-5

May 2015
Looking South

2015 Beach
Erosion Update
Conditions

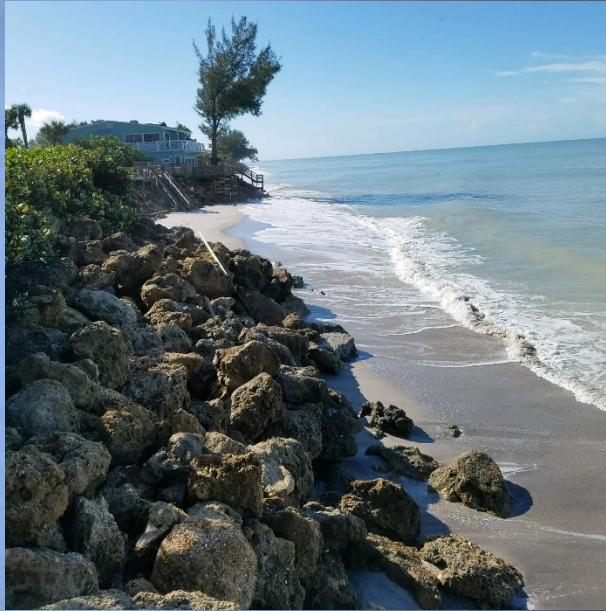
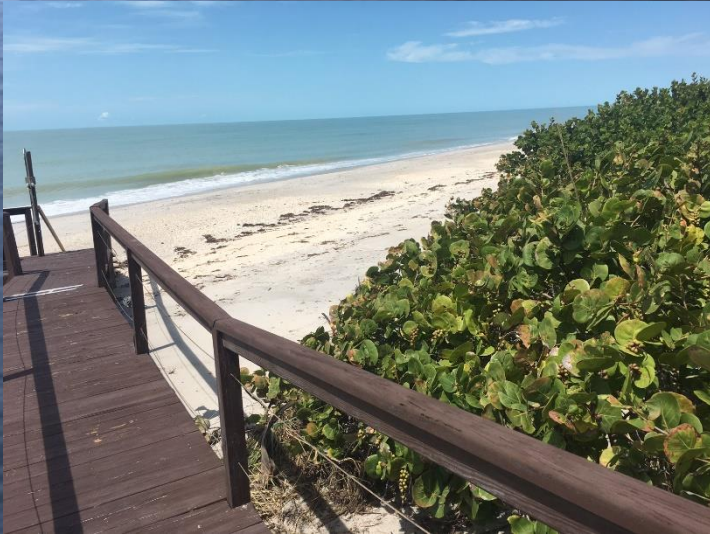
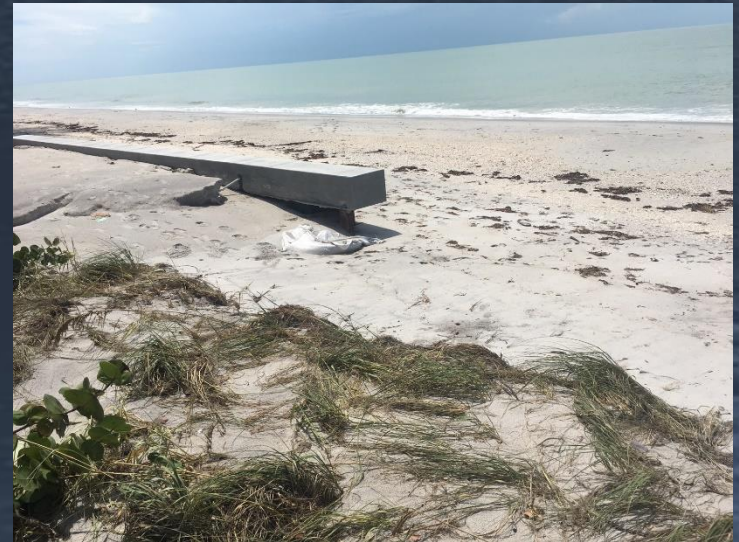
POST-IRMA CONDITIONS

- Some Segments Experienced Erosion While Other Segments Experience Accretion
- Minor Flanking of Armoring Structures
- No Net Increase in Design Quantities for Restoration Plan
